**CONNECTICUT RIVER BASIN  
HADDAM, CONNECTICUT**

**HIGGANUM RESERVOIR DAM  
CT 00430**

**PHASE 1 INSPECTION REPORT  
NATIONAL DAM INSPECTION PROGRAM**

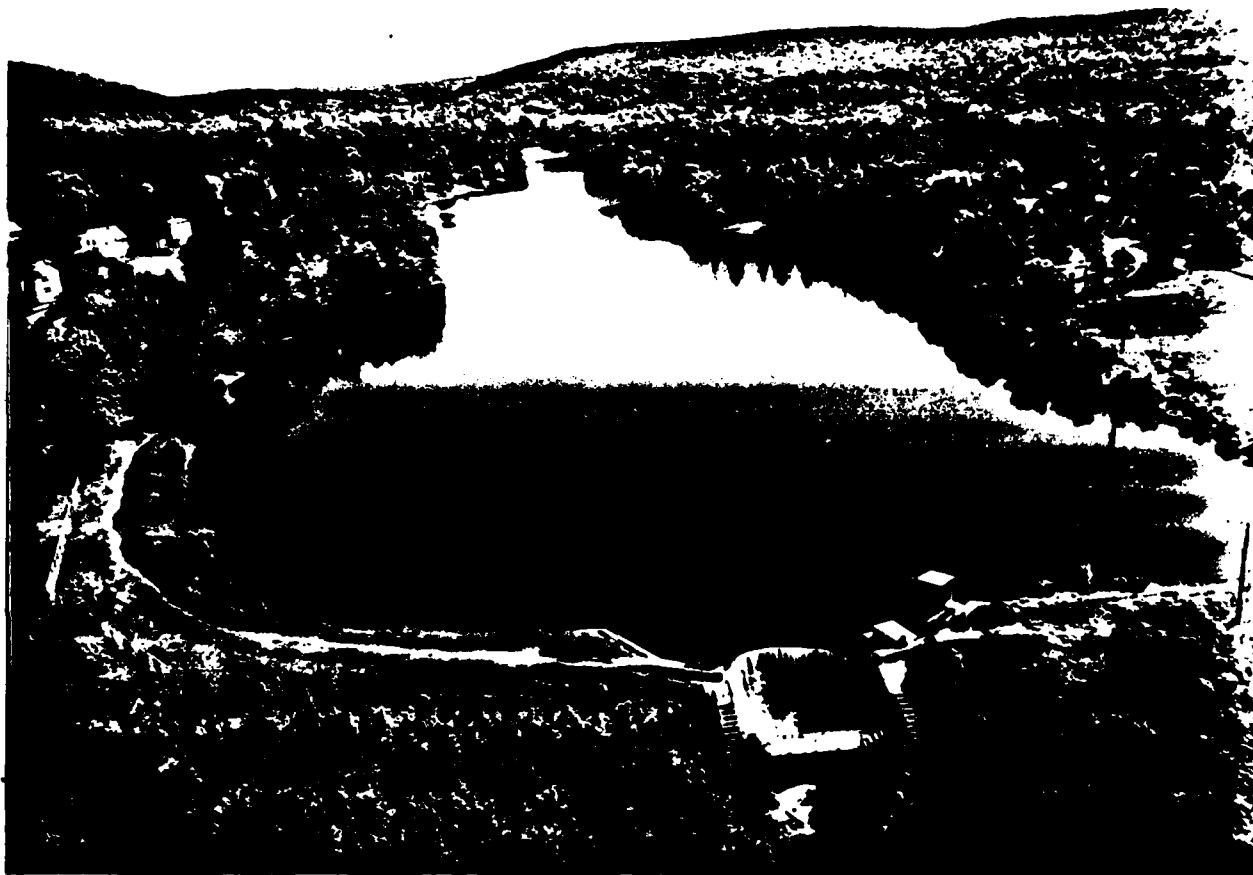
C-1 HIGGANUM RESERVOIR - LOOKING UPSTREAM

- b. Dam: The top surface of the embankment on both sides of the spillway is grassed with a worn footpath along the entire length, see Photo C-1. There is an apparent small 12 inch deep path along the top of the dam between Sta 5+0 and 7+0 (Refer to Appendix B-3 for stationing). Riprap appears to be absent at many locations along the upstream face. Many trees and brush are growing on the upstream face, as well. An example of this growth on the upstream face of the dam is shown in Photo C-4.

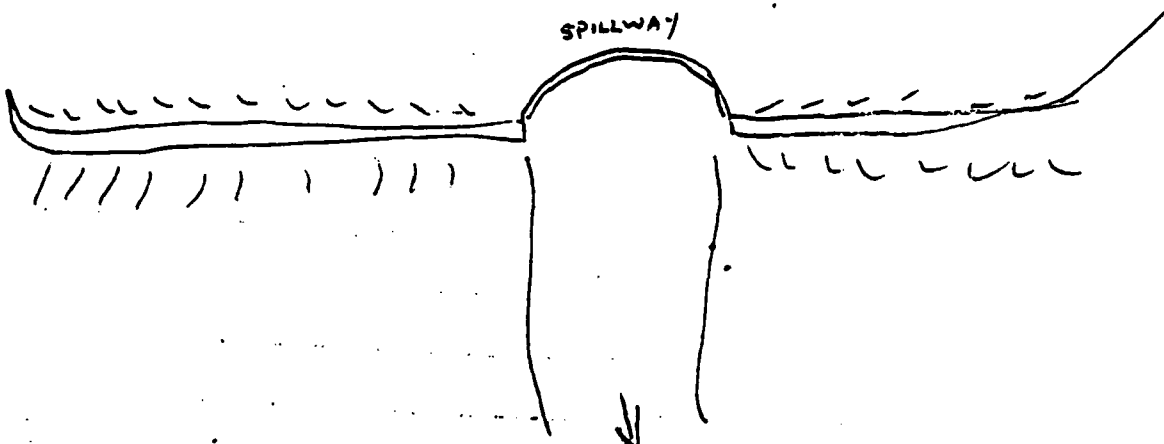
10-27-77 BRUSH ON SLOPES. SEEPAGE ALONG  
TOE E. OF OUTLET & ABOUT HALF WAY  
UP SLOPE ON WEST SIDE SHOULD BE  
MAINTAINED PER.

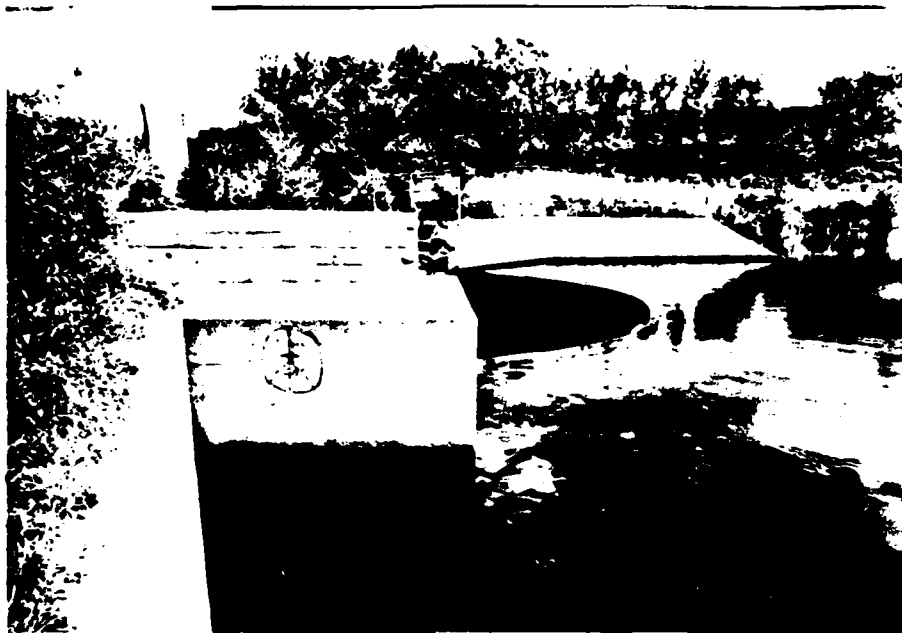
C-2 OVERALL VIEW OF SPILLWAY FROM LEFT EMBANKMENT

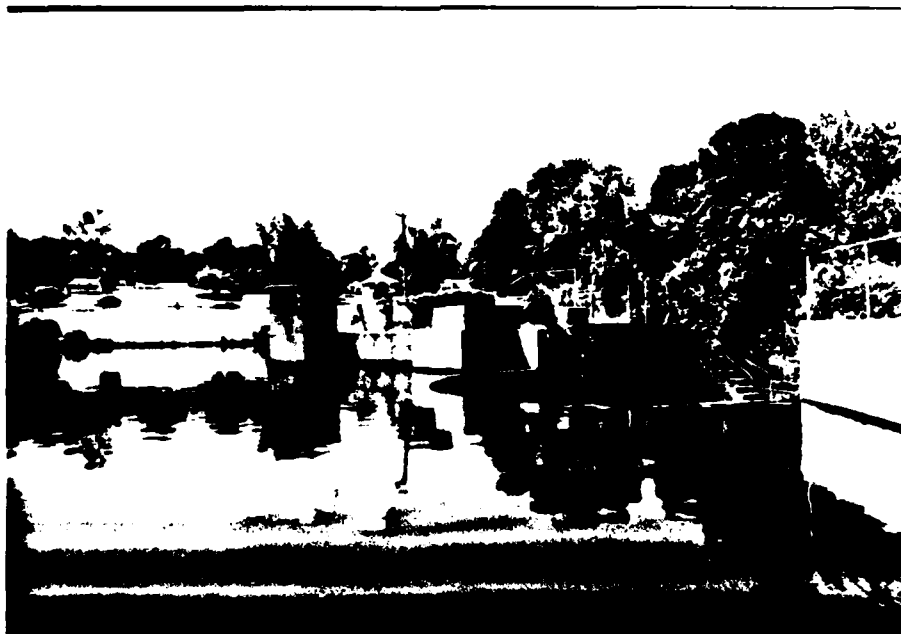
C-3 OVERALL VIEW OF SPILLWAY AND GATEHOUSE FROM RIGHT EMBANKMENT

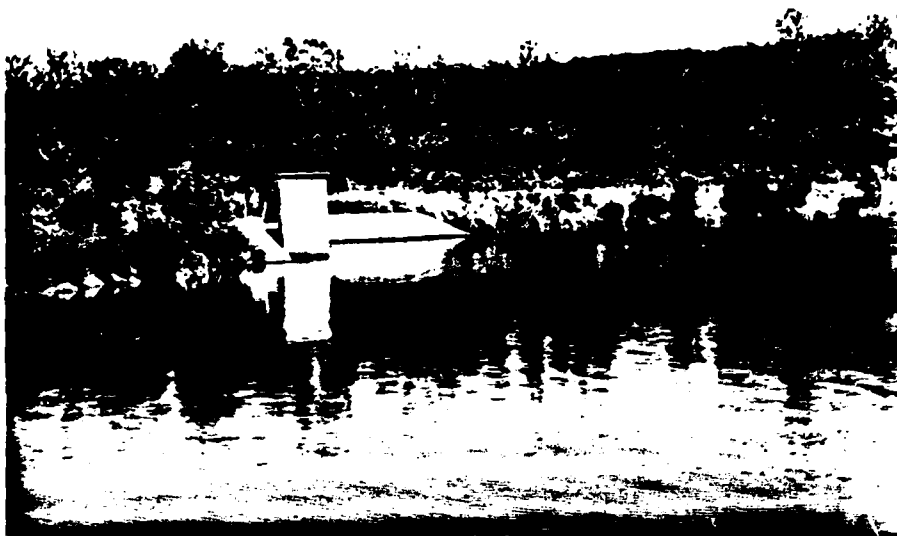
C-4 OVERALL VIEW OF DAM FROM RIGHT SIDE OF RESERVOIR  
SHOWING EARTH EMBANKMENTS AND GATEHOUSE.

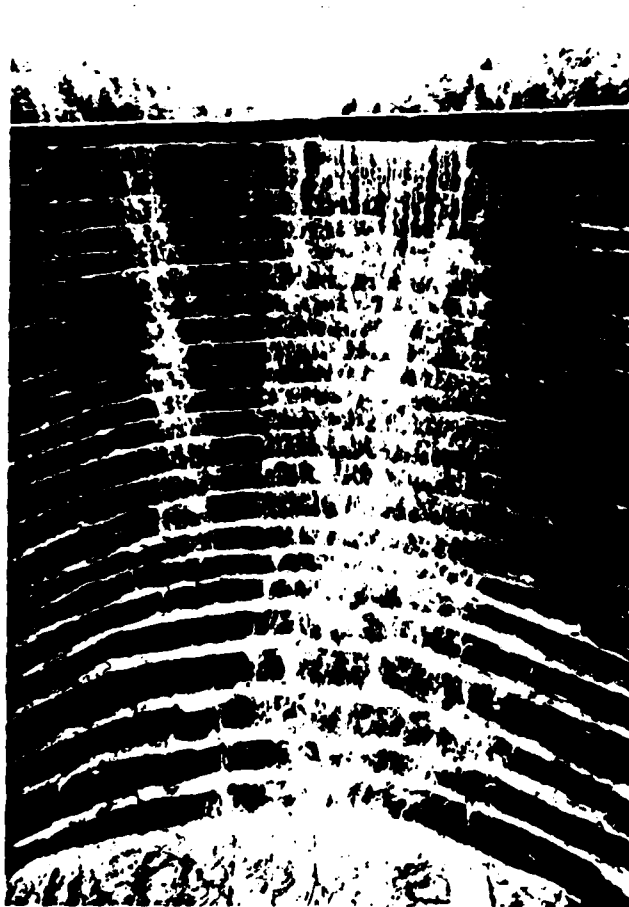
C-5 VIEW OF FACE OF SPILLWAY

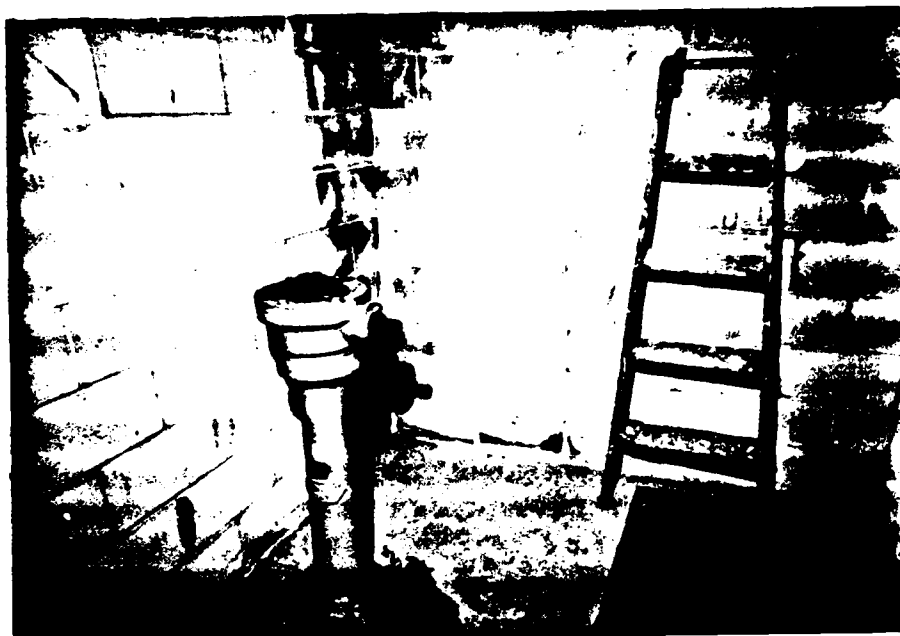
All gate operations at the dam are directed by the Hartford office of the Department of Environmental Protection (D.E.P.). The gate, reportedly, has not been operated since 1972. An operational check of the gate was performed at the time of the visual inspection and the mechanism and gate functioned satisfactorily. The gatehouse and lift mechanism appeared to be in good condition.

C-10 INTERIOR OF GATEHOUSE SHOWING GATE  
OPERATING MECHANISM
